Site 56 – Pinole Creek Tributary

Site Coordinates

566485, 4202587

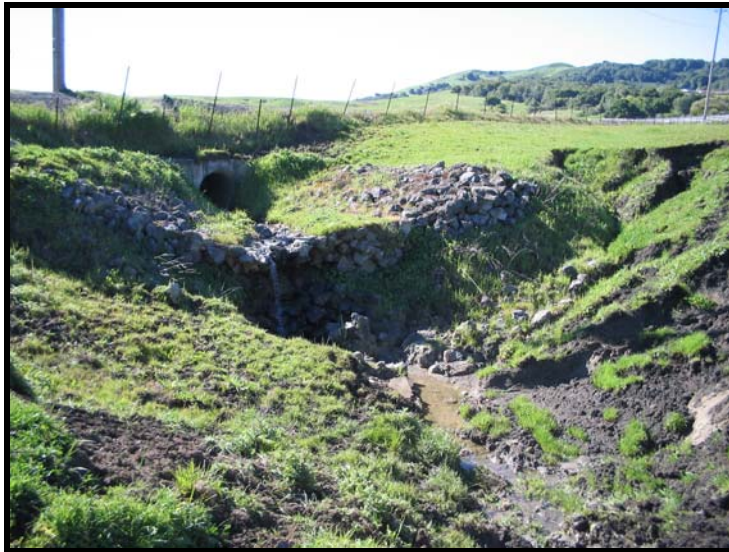
RISK JUSTIFICATION: Primary attributes are high. Channel actively degrading. Incision leading to active bank slumping and instability. Secondary criteria also trending to high risk.

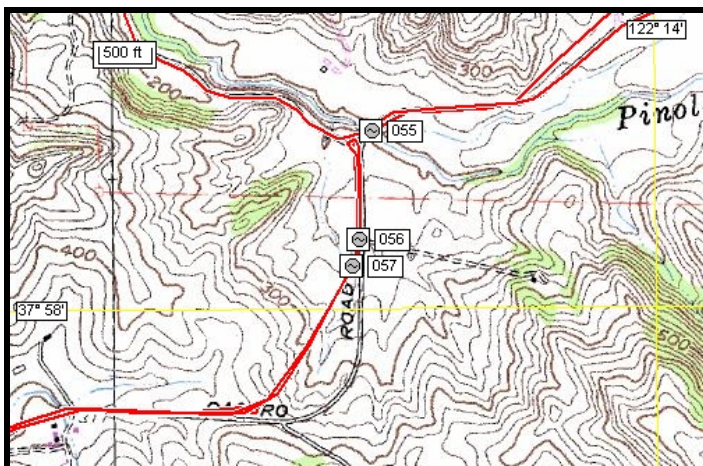
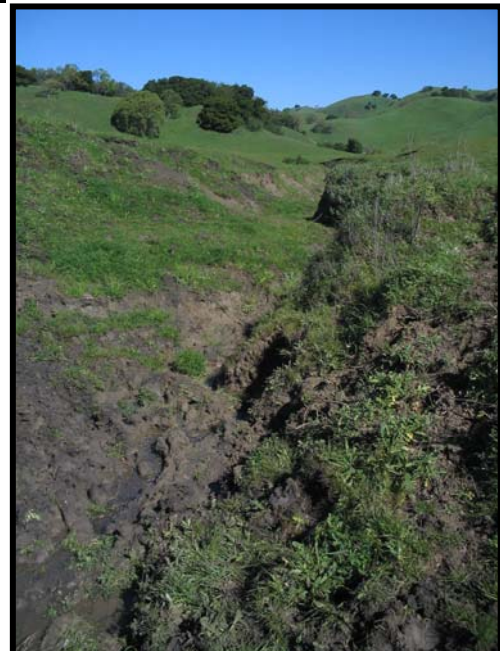
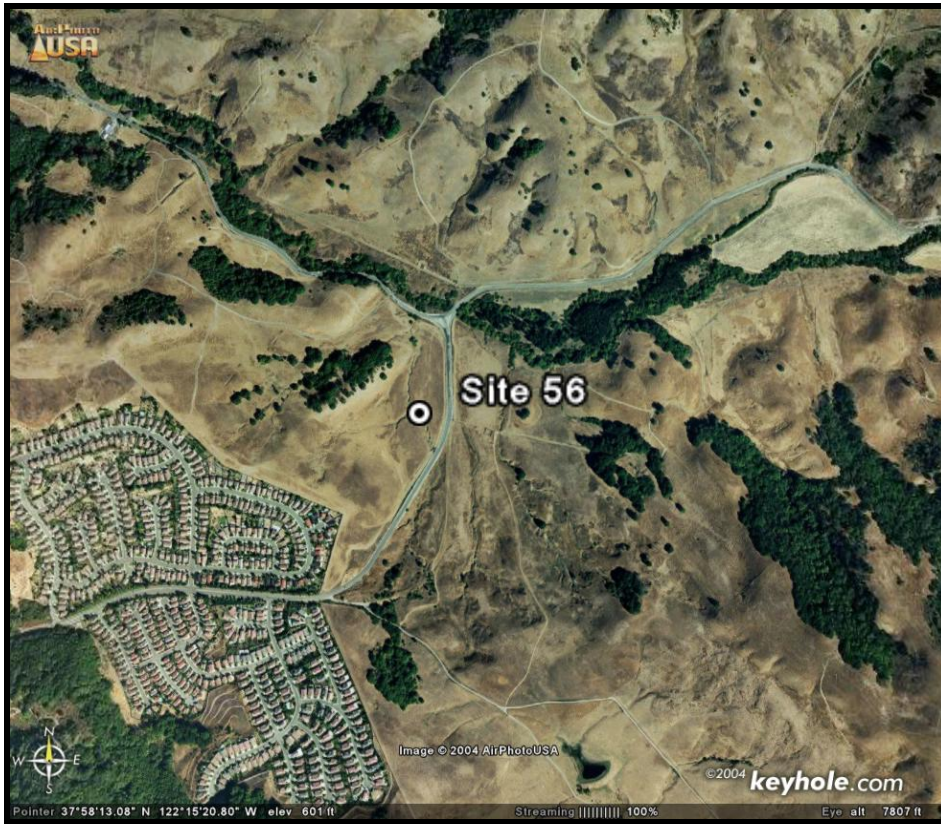
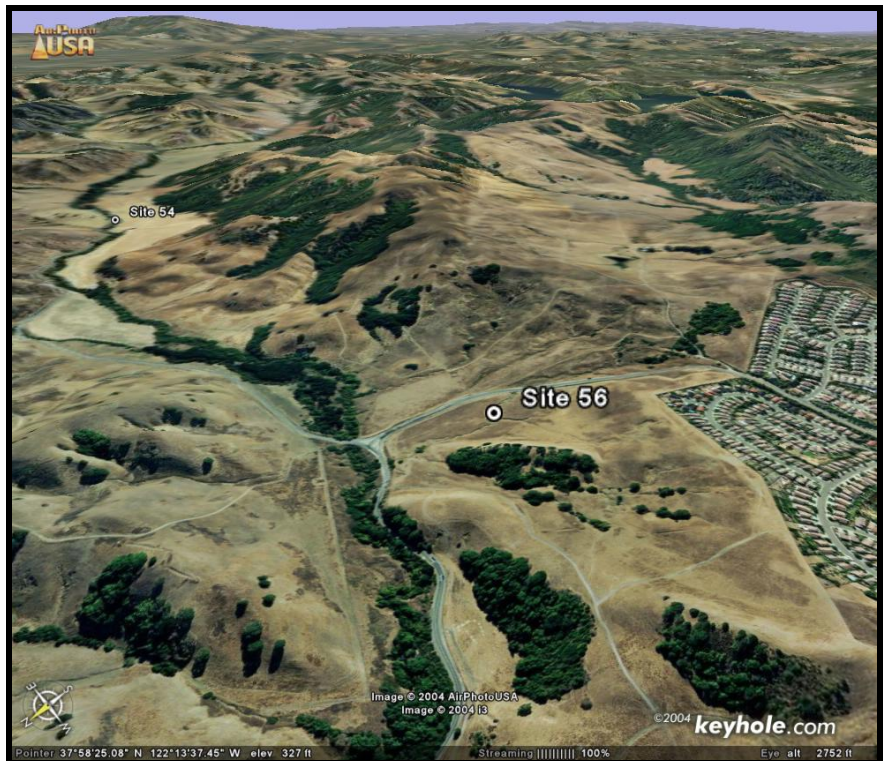
SITE NOTES: Massive degradation of channel due to incision and destabilized bank failures under existing land-uses. Degradation partially due to poorly designed and/or maintained infrastructure.
