**Site 56 – Pinole Creek Tributary****Site Coordinates****566485, 4202587****Site Datum:****UTM WGS 1984**

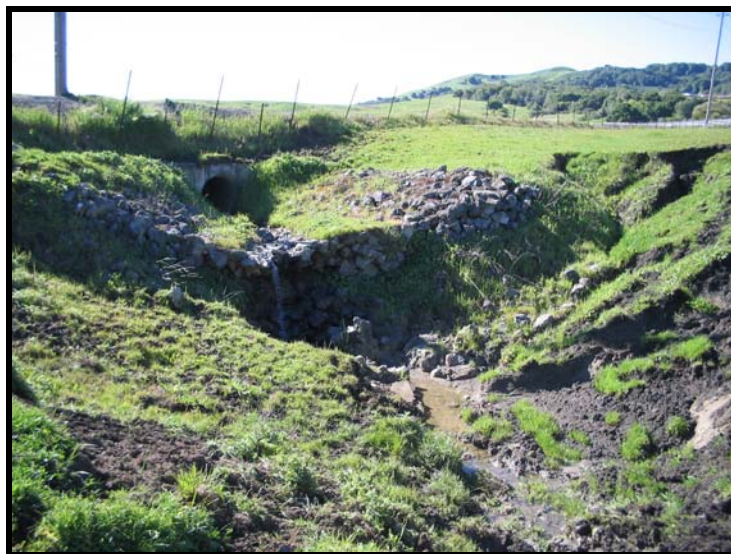
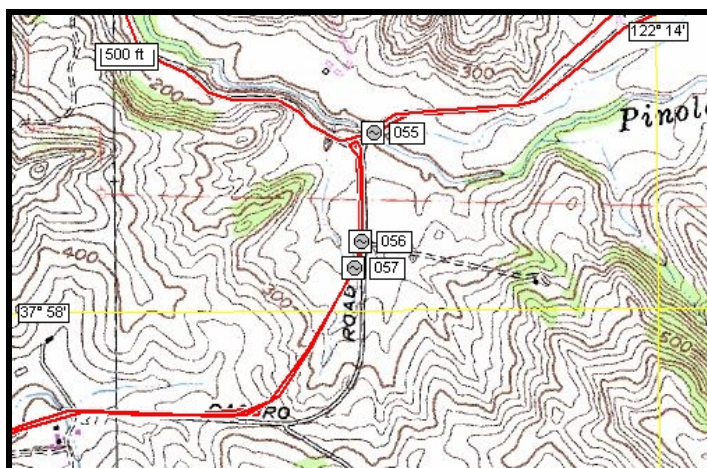
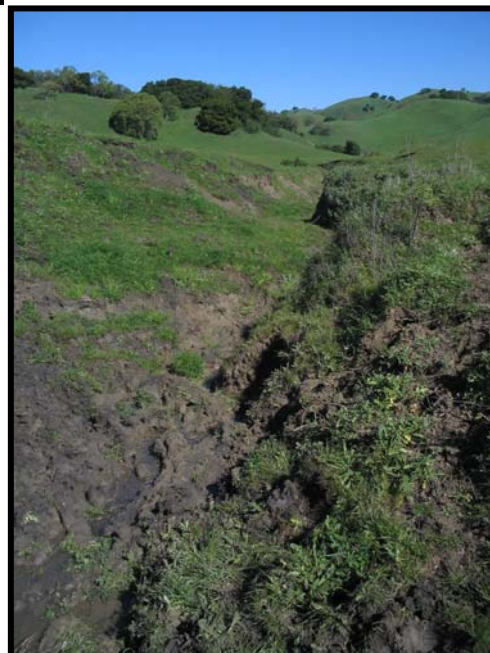
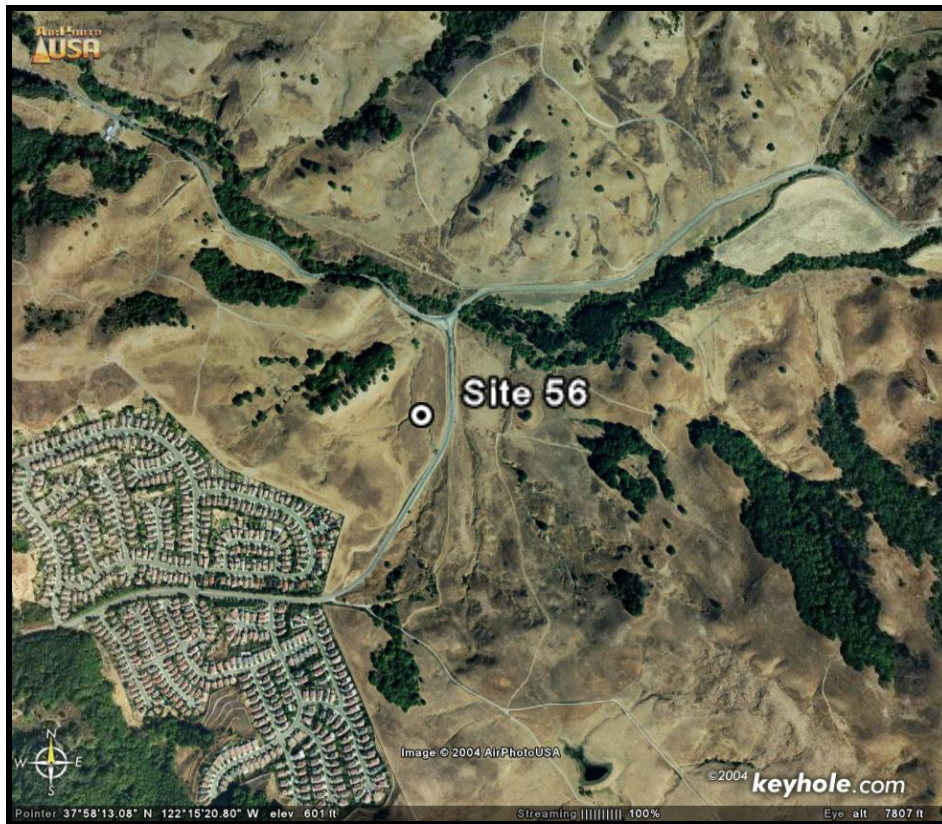
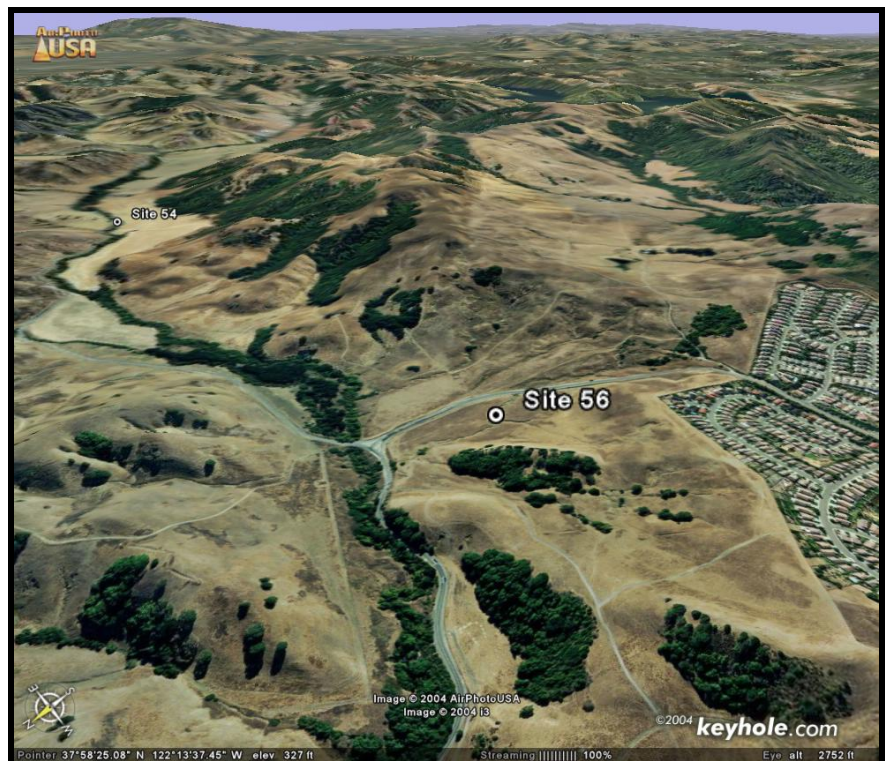
**RISK JUSTIFICATION:** Primary attributes are high. Channel actively degrading. Incision leading to active bank slumping and instability. Secondary criteria also trending to high risk.

**SITE NOTES:** Massive degradation of channel due to incision and destabilized bank failures under existing land-uses. Degradation partially due to poorly designed and/or maintained infrastructure.
