# Benchmark Electronics – Slug Discharge to the Storm Drain System

Jeremy Talarico  
Environmental Compliance Inspector II  
Central Contra Costa Sanitary District

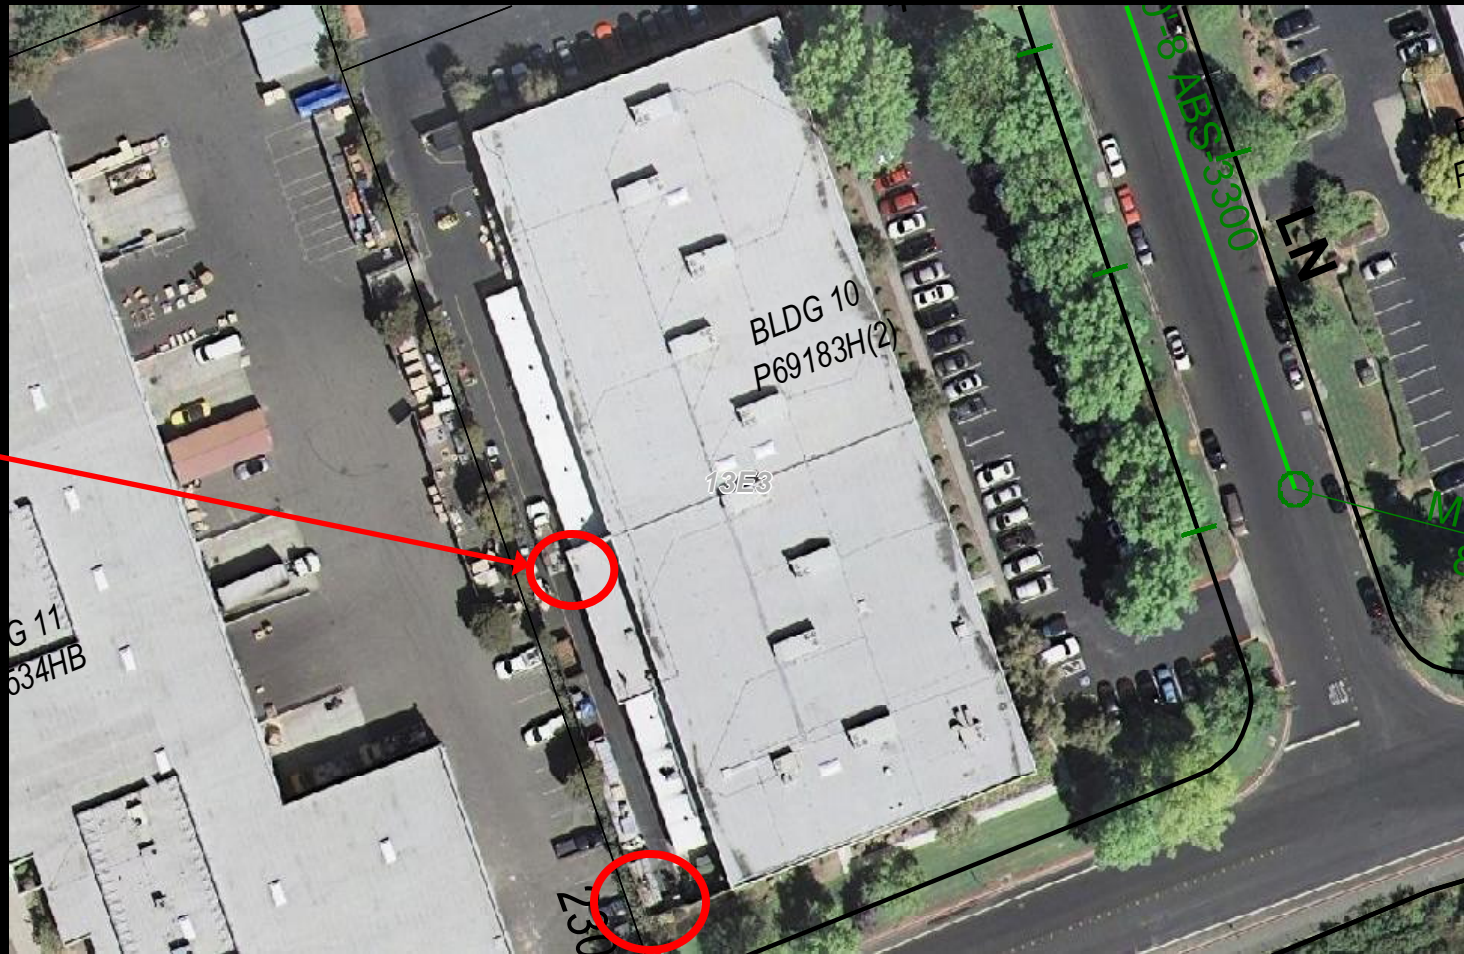
# Benchmark Electronics – Location

Coolant  
exited  
building  
here

Storm Drain Location (about 130 feet from exit point)
