Site 65 – Pinole Ck

Site Coordinates

570927, 4200653

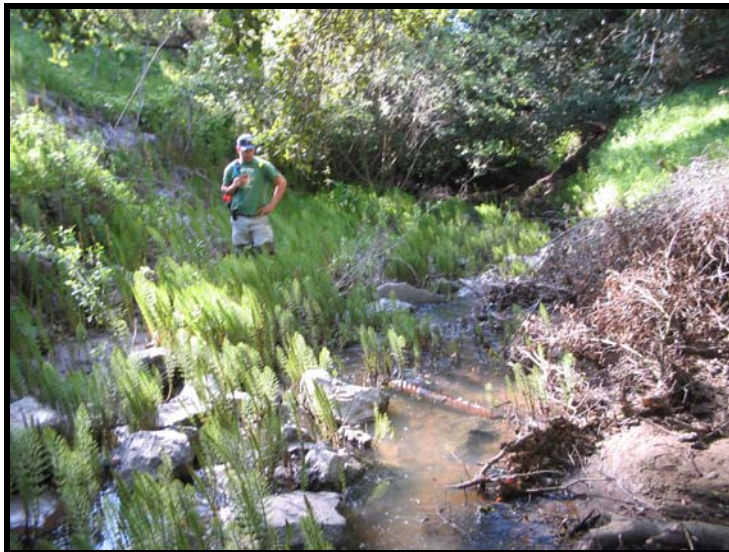
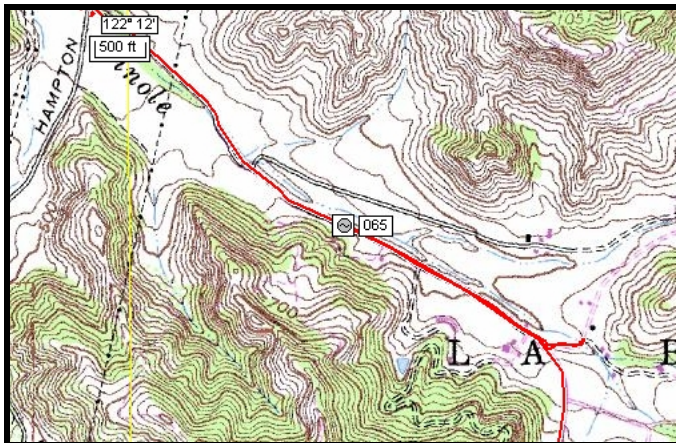
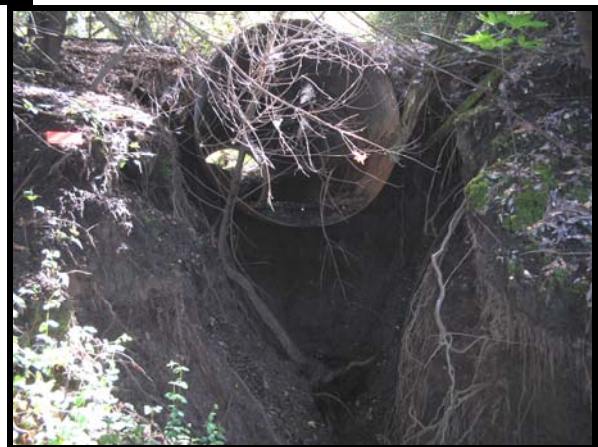
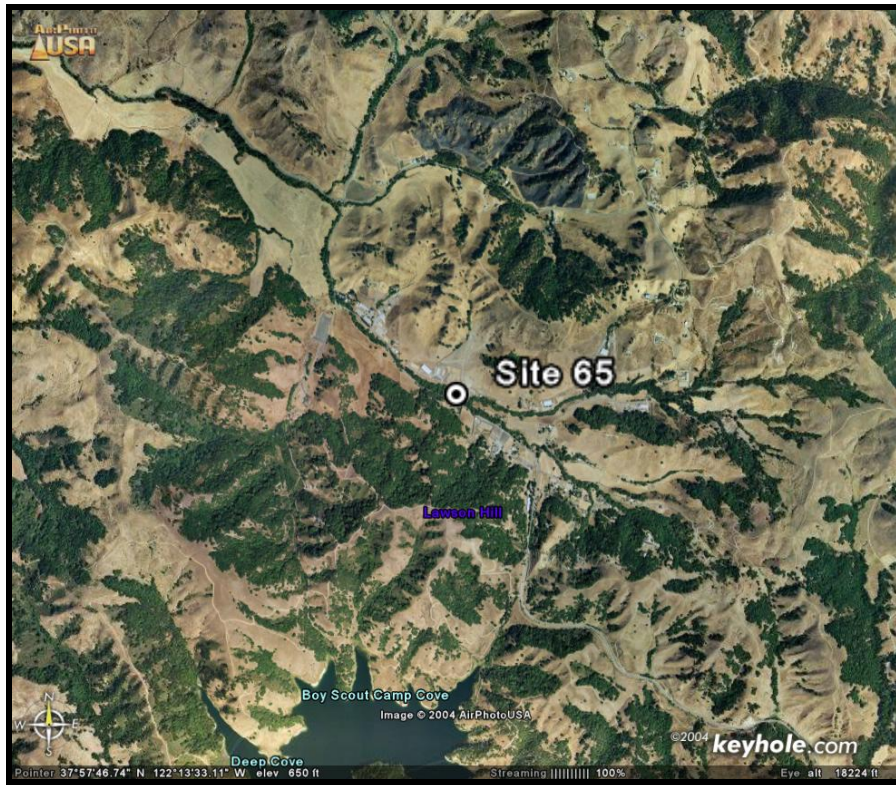
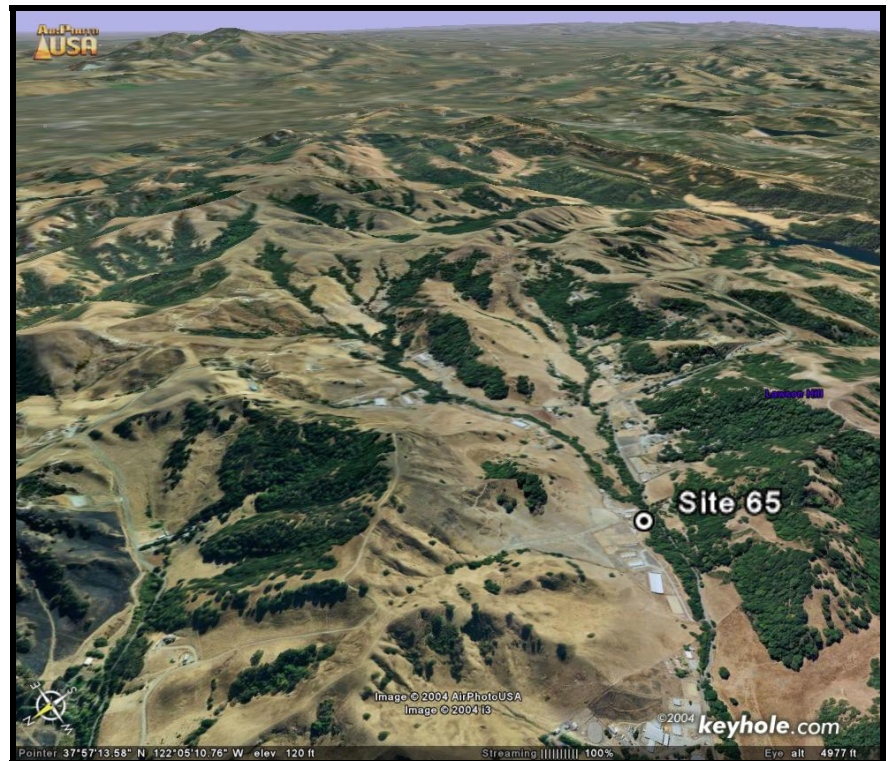
RISK JUSTIFICATION: Primary and most secondary attributes are mixed. Sediment supply is high due to local erosion sources, artificially aggrading the bed. Steep valley side slopes and local erosion sources indicate excessive sediment load that, if reduced, could result in long-term degradation of the channel bed.

SITE NOTES: Localized channel aggradation due to large inputs of sediment from failing culverts and road fill failures adjacent to channel. Pool-riffle channel with localized trash and debris buried in channel, offering artificial stabilization features.
