Site 60 –Releiz Creek

Site Coordinates	370331, 4130342	Sile Daluin.	01W WG5 1304
Entrenchment Ratio	1.9 (m)	Active bank erosion	Moderate (m)
Secondary Attributes		Bed Materials	gravels & silt (m)
Bankfull Depth (ft)	1.3	Average Gradient	0.04%

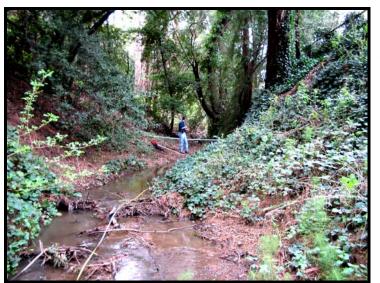
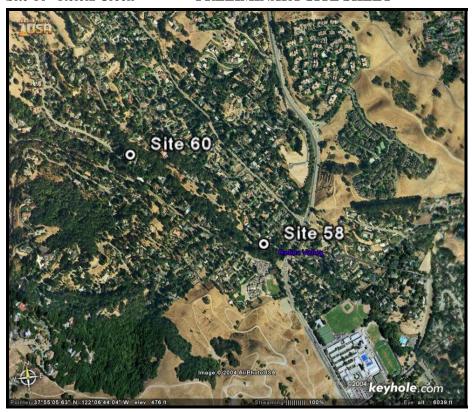
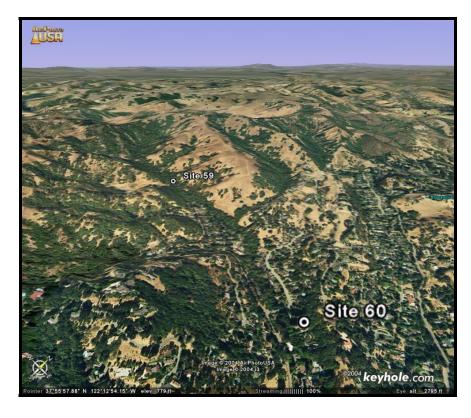
RISK JUSTIFICATION: Primary criteria are moderate. Reaching apparent stability with surrounding sub-urban land use. Coarse substrate limits further incision. Deposition of alluvium within valley indicates dynamic erosion and deposition processes are active, an indication of dynamic equilibrium. Existing land-use largely developed.

SITE NOTES: Confined channel within sub-urban land use area. Valley walls appear stable and well vegetated. Gravels and fines are mixed in substrate. Simple channel with small pools and debris-formed steps. Minor localized incision in confined sections.
