Site 74 – Briones Valley Headwaters

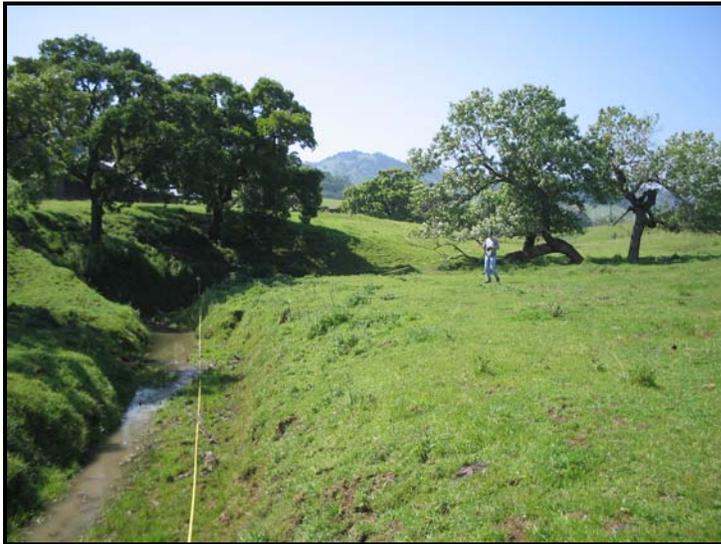
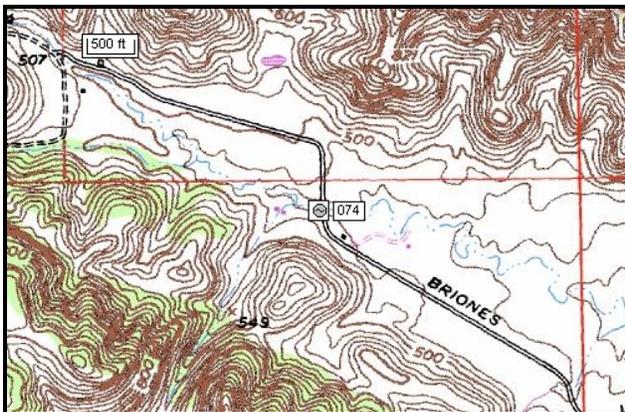
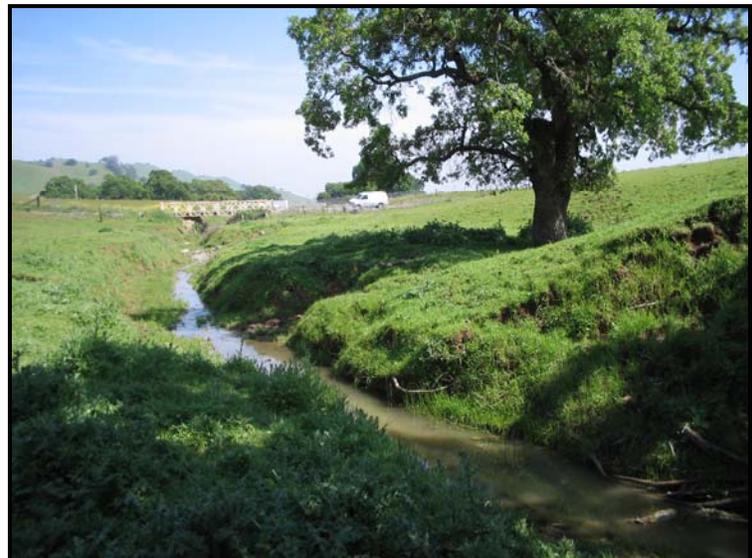
SITE NOTES: Locally steep eroded bluffs providing a moderate amount of sediment supply. Banks mostly stable and well vegetated. Occasional boulders and bedrock blocks in channel. Channel incised about 9 feet into valley floor.

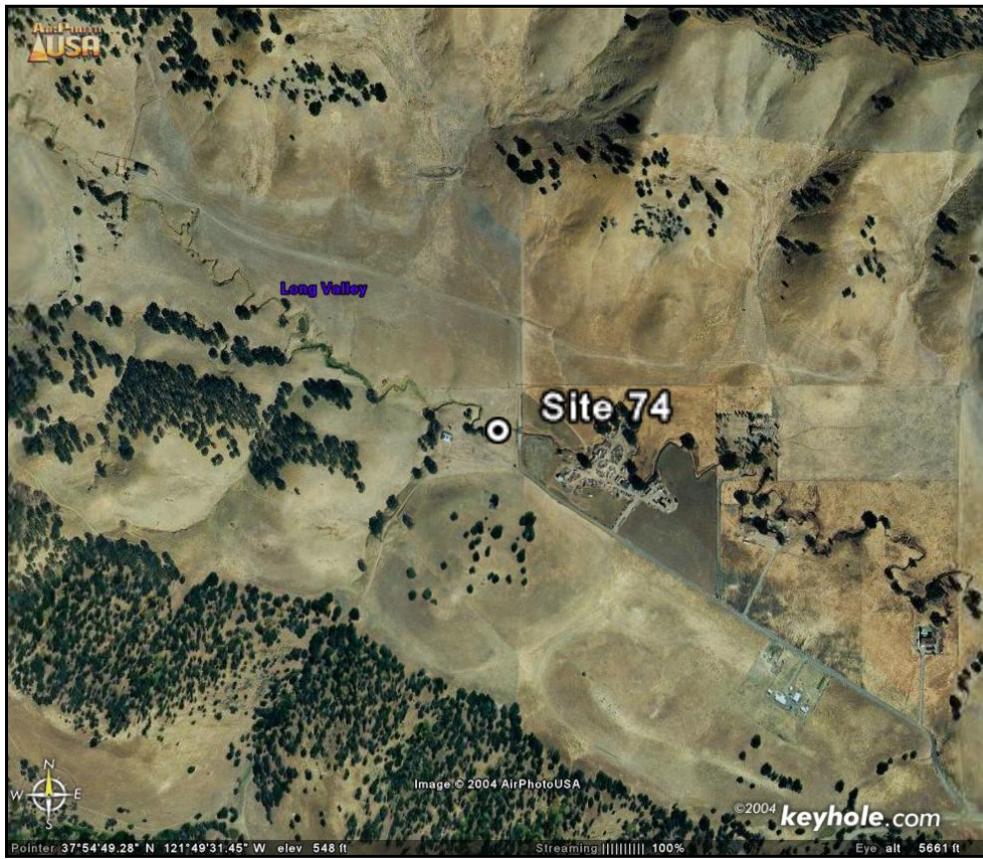
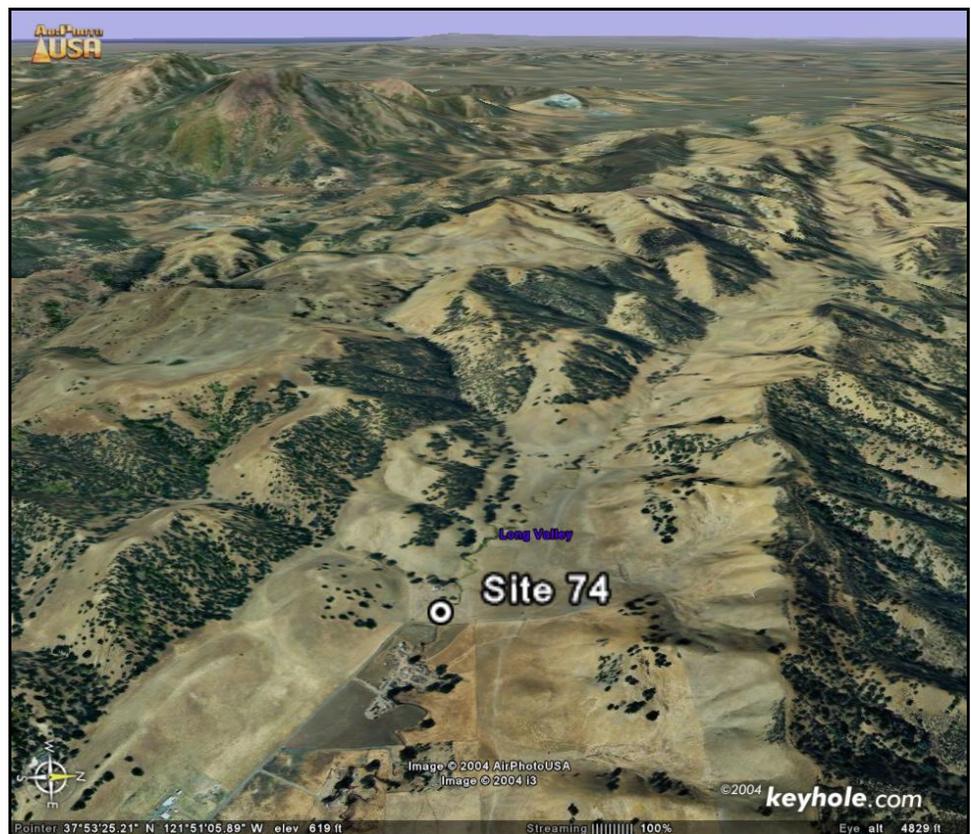
Primary Attributes		Confinement Class	WC (H)
Entrenchment Ratio	1.06 (H)	Active bank erosion	Moderate
Entrainment Ratio	1.22 (H)	Active sediment supply	Moderate
Secondary Attributes		Bed Materials	silty clay (H)
Bankfull Width (ft)	9	Bank Materials	silty clay (H)
Bankfull Depth (ft)	0.5	Average Gradient	0.58%
Width/Depth Ratio	18.0 (M)	CLASSIFICATION	HIGH

RISK JUSTIFICATION: Primary attributes are High. Fine substrate combined with evidence of localized bank erosion and significant channel incision under existing conditions; moderate supply of sediment will help maintain an alluvial mantle and prevent incision, although reduction in supply could destabilize the channel; high width/depth ratio may be a result of channel widening associated with cattle-driven sedimentation.
